HM Government of Gibraltar

Report on the investigation of the collision of

OS 35 and ADAM LNG

And the subsequent grounding of

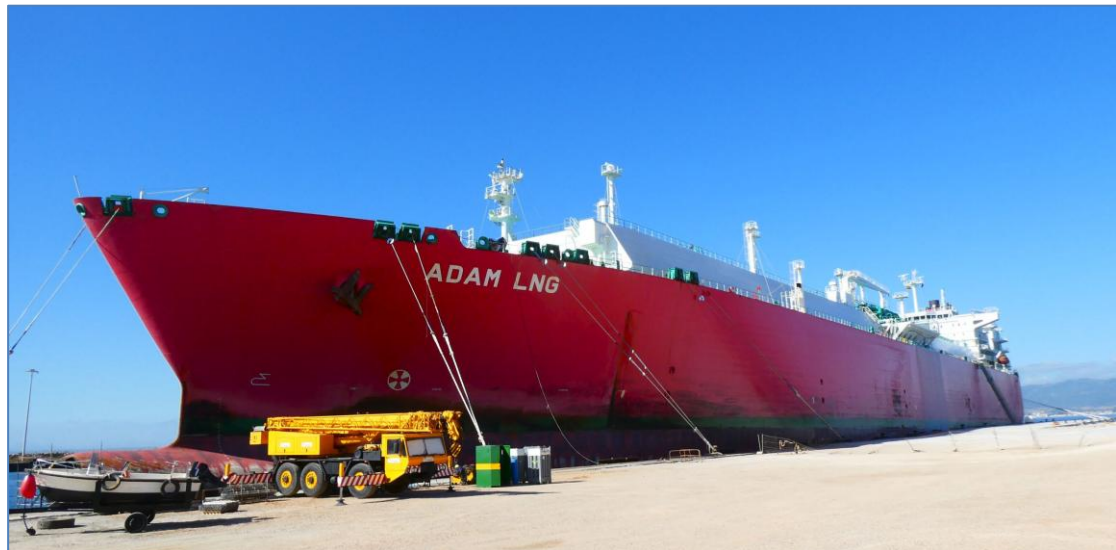
Figure 2 'ADAM LNG' – alongside after the collision

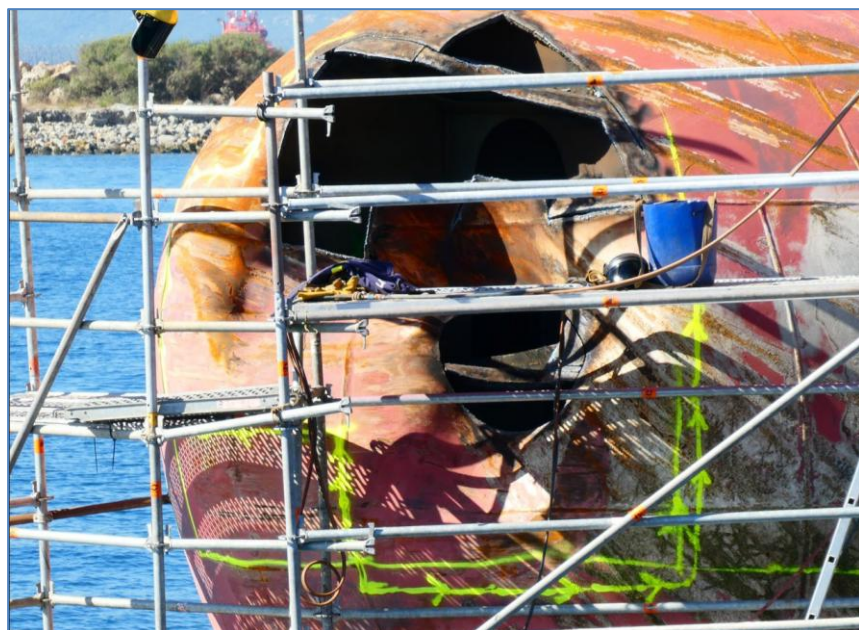
The bulbous bow of 'ADAM LNG' sustained minor damage as shown at Figure 3 below. The damaged steel was repaired with the vessel alongside.

Figure 3 Damage to the bow of 'ADAM LNG' under repair

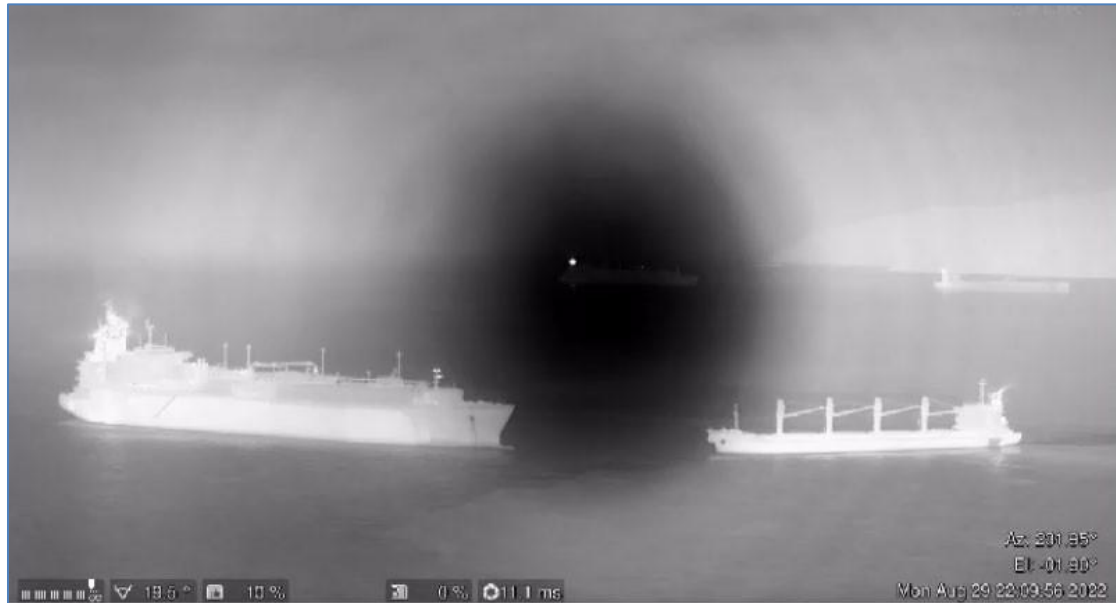
The VTS CCTV image taken immediately prior to the collision shows, at Figure 4 below, that the winds were light, and from the anchor cable of 'ADAM LNG' - being almost "up and down" throughout the recording - that the tidal flow was weak. Anchored vessels in the Western Anchorage were heading in a generally northerly direction which indicates that the general direction of the tidal flow at the time was southerly.

Figure 4 VTS CCTV image showing the wind conditions and 'ADAM LNG's anchor cable prior to the collision

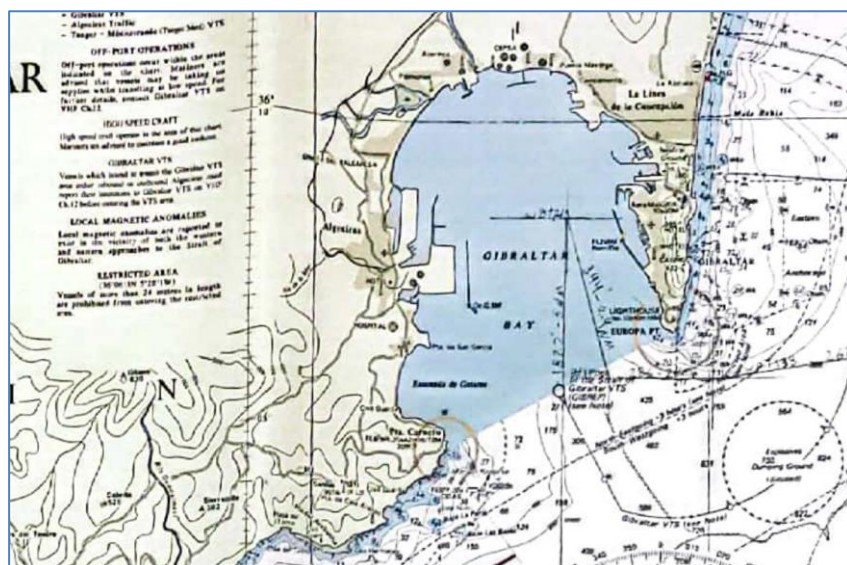
The passage plan identified a waypoint in the centre of Gibraltar Bay which was plotted on the back-up paper chart shown at Figure 7 below. The route is also not shown on the ECDIS playback recording.

Figure 7 Chart extract of the chart recovered from 'OS 35'

The departure from the 'OS 35' anchorage position was not plotted and the existing prior passage plan was not amended for the actual anchor position.

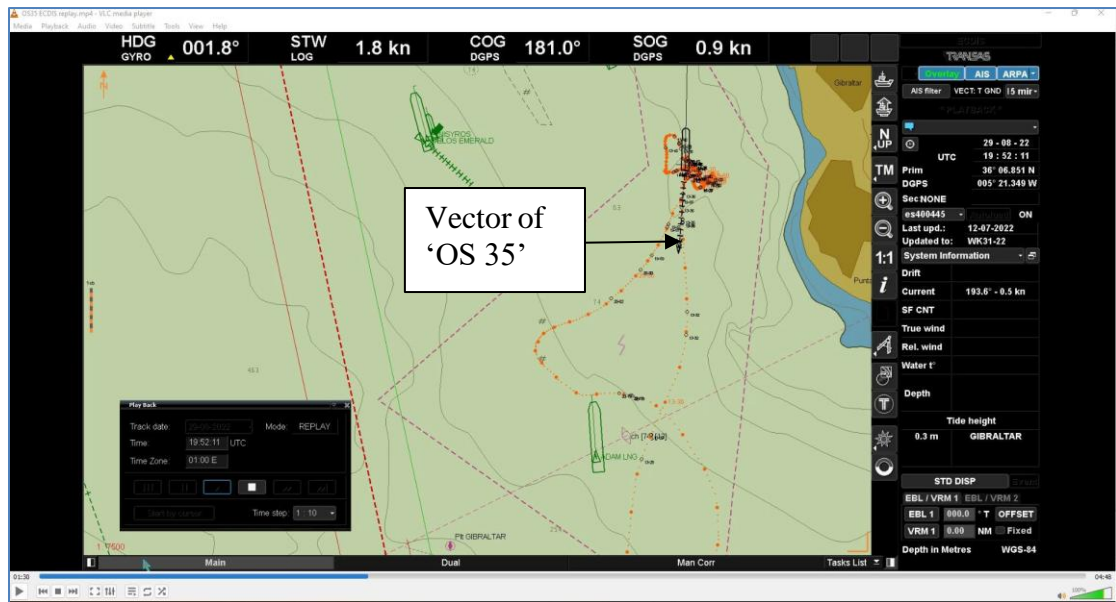
The screenshot at Figure 20 shows the ECDIS display recovered from 'OS 35' after the collision. The vector shows the projected path of the vessel should the displayed COG and SOG be maintained. The vector does not take into account the vessel's Rate of Turn (ROT)

Figure 20 'OS 35' ECDIS display showing the vector with SOG and COG

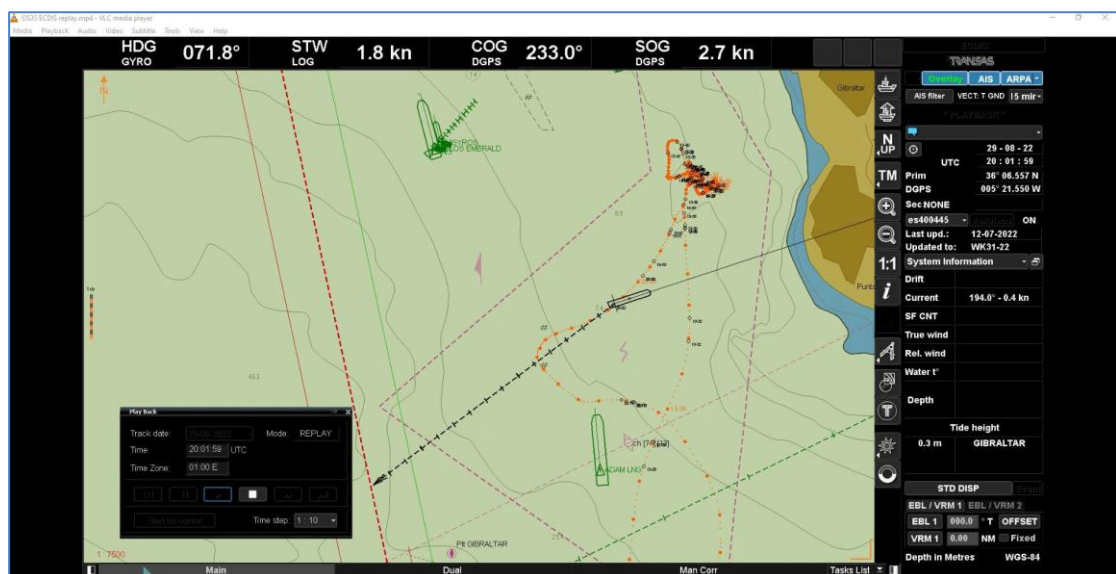
The breadcrumb track and vector shown at Figure 21 at 22:01:59 when the master stopped the engine operating astern and started to apply power ahead, and placed the rudder hard to port, predicted that 'OS 35' would pass clear of 'ADAM LNG' at a distance of around 2 cables.

Figure 21 'OS 35' ECDIS display at 22:01:59

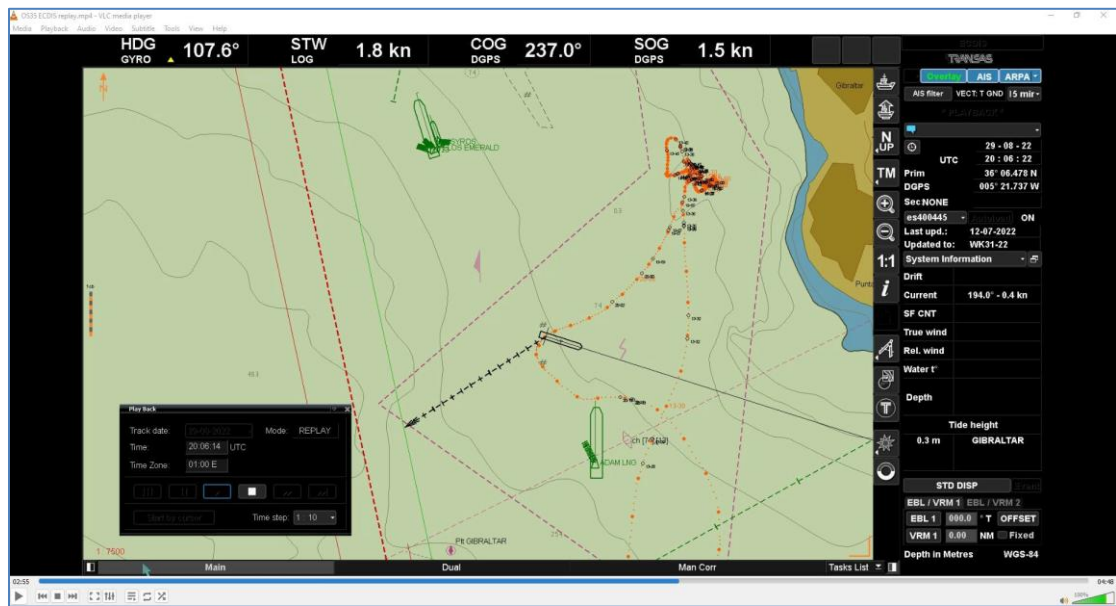
Had either the master or the second officer effectively monitored the track of 'OS 35' they would have observed that, as the heading continued to swing to starboard as shown at Figure 22 at 22:06, that the existing manoeuvre was providing an effective clearing distance from 'ADAM LNG'.

Figure 22 'OS 35' ECDIS display at 22:06:14

The master's perception of the effect of tidal flow and wind was, as shown at Figure 22, incorrect. The evidence available to the master from the wind, and other vessel's anchors during the early part of the manoeuvre and the information from the ECDIS would have provided both the master and second officer with the evidence required to show that tidal flow and wind were not significant factors.

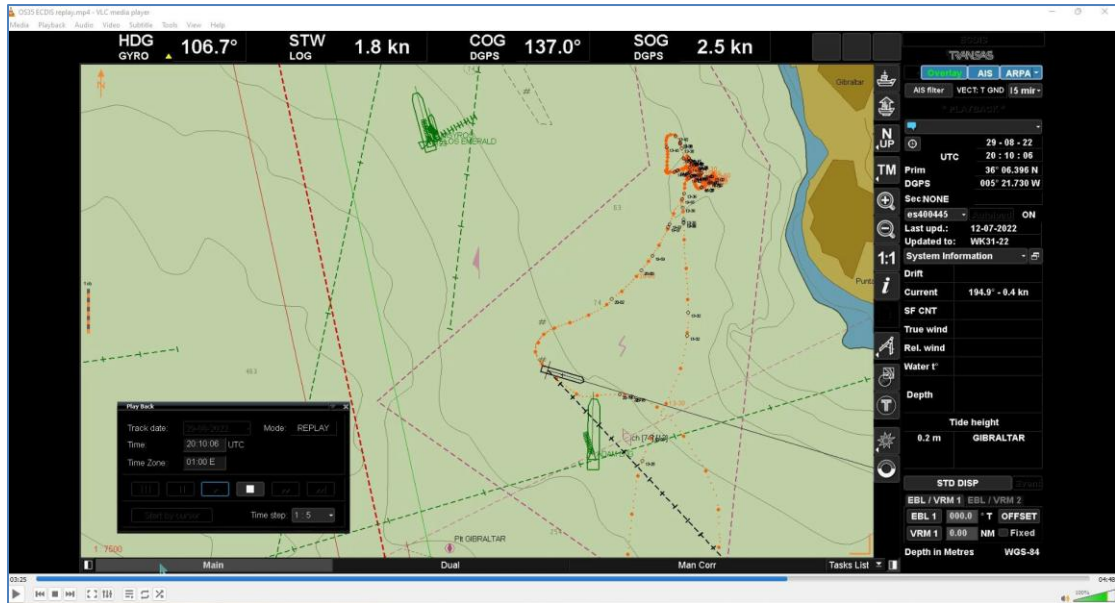
The effect of the master's revised manoeuvre of full ahead propulsion and the rudder placed hard to port manoeuvred the stern of 'OS 35' towards 'ADAM LNG' as shown at Figure 23. The master's decision was not effectively challenged by the second officer, who was not consulted by the master as to whether the change of plan would be effective and did not monitor the vessel's track to advise the master accordingly.

Figure 23 'OS 35' ECDIS display at 22:10:06

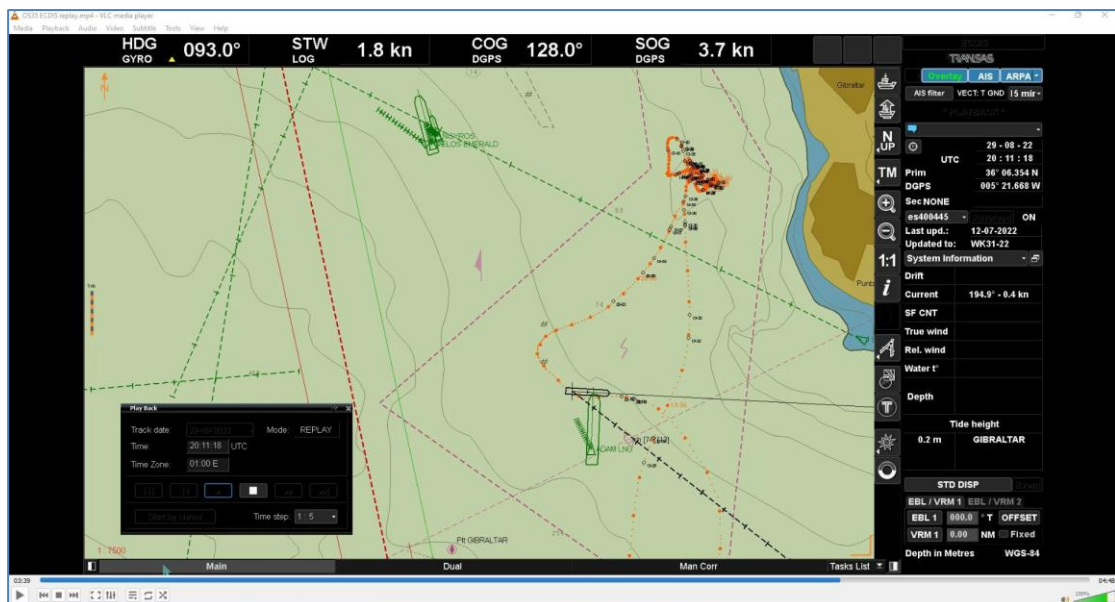
The ECDIS vector that showed the change of COG and SOG during the manoeuvre was available to the master and second officer; however, this vector did not alert either of them that their actions were increasing, rather than decreasing, the risk of collision with 'ADAM LNG' as shown by the vector of 'OS 35' shown at Figure 24 below.

Figure 24 'OS 35' ECDIS display at 22:11:18

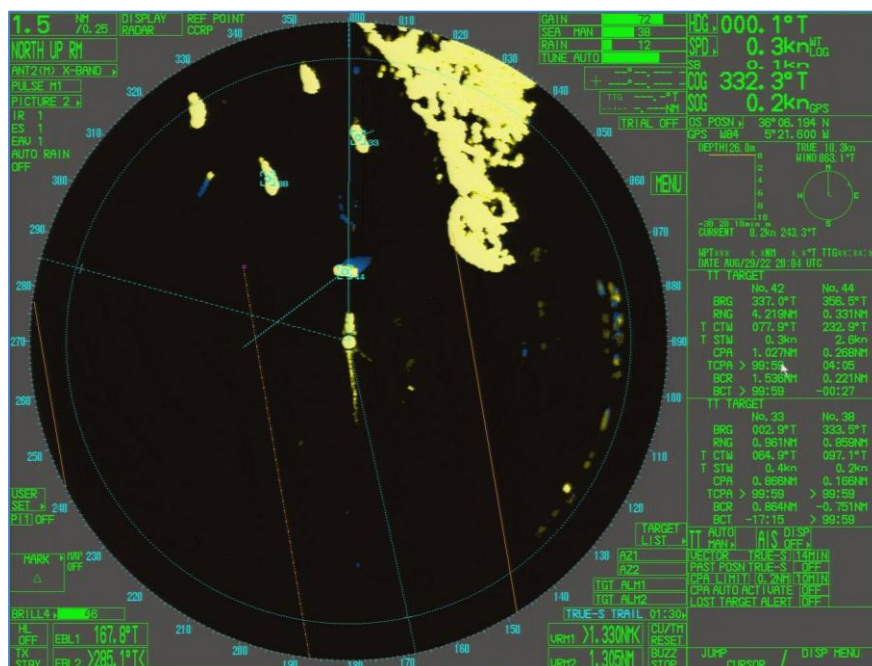
Figure 26 Radar Image from 'ADAM LNG' showing the position and vector of 'OS 35' at 22:04

The earliest that a change to the manoeuvre of 'OS 35' could have been observed by the 'ADAM LNG' OOW would have been at around 22:04. The risk of collision would only have been fully apparent to the OOW around 2 minutes prior to the collision. This time period did not provide the OOW sufficient time to take any action, such as using the engine or releasing anchor cable, to prevent the collision.
