You're Grounded!

The grounding of a passenger vessel prompts large-scale response effort.

by LTJG NICK BARROW
Public Affairs Officer, U.S. Coast Guard Sector Portland

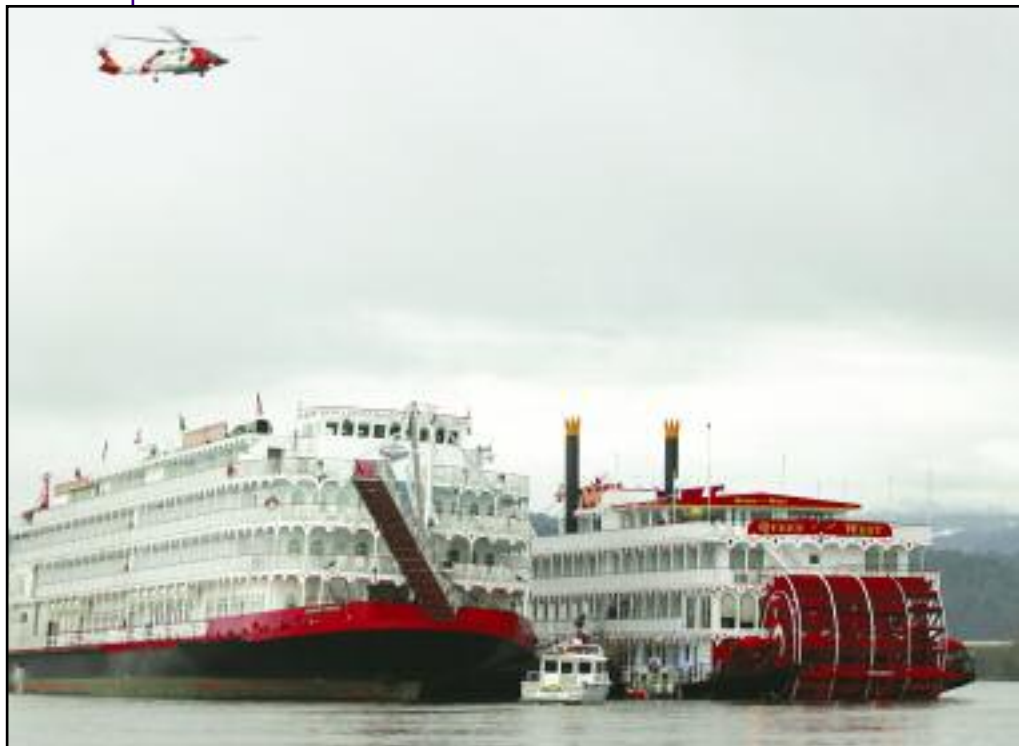
Figure 1: The *Empress of the North* (left) transfers passengers and non-essential crew to its sister ship, the *Queen of the West* (right) as an HH-60J from Air Station Astoria flies overhead, monitoring the incident. Response boats from Station Portland and the Multnomah County Sheriff's office are also on scene to assist with the transfer. USCG photo by PA1 Amy Gaskill, USCG (ret).

Despite making the Columbia River voyage more than 100 times since being built in 2001, the 360-foot *Empress of the North* took an unexpected and nearly disastrous turn recently, and Sector Portland was ready to answer the call. The grounding occurred near Washougal, Wash., just 20 miles east of Portland, Ore. The vessel would remain there for 54 hours, and motivate a multi-agency response that captured the attention of thousands (Figure 1).

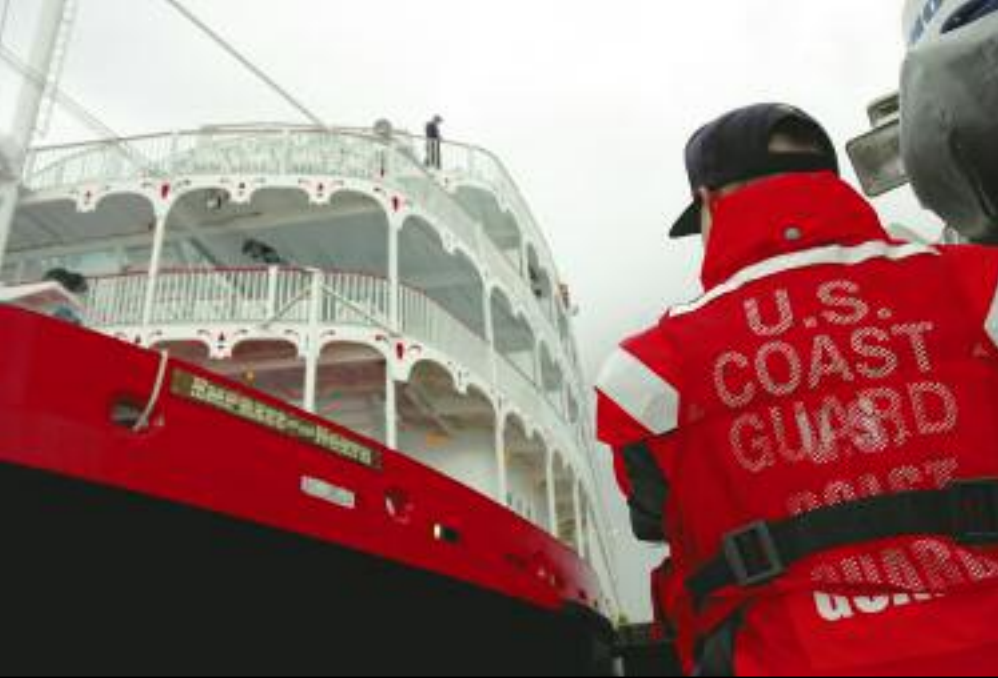
Figure 2: CWO4 Eric Olson approaches the *Empress* to assess the vessel's condition, as plans were being developed to transfer passengers. LT Zeke Lyons (seen on the bridge wing), a marine casualty investigator, obtains information from the bridge. USCG photo by PA1 Amy Gaskill, USCG (ret).

Right across from Sector Portland's Base and only a thirty-minute transit away from the grounded vessel, the *Queen of the West*, sister ship to the *Empress of the North*, had just completed a scheduled dry dock maintenance period. The owner, American West Steamboat Co., agreed to offer the services of the *Queen of the West* as a rescue vessel. The unified command directed the ship and a mooring barge into position alongside the *Empress of the North* (Figure 2).

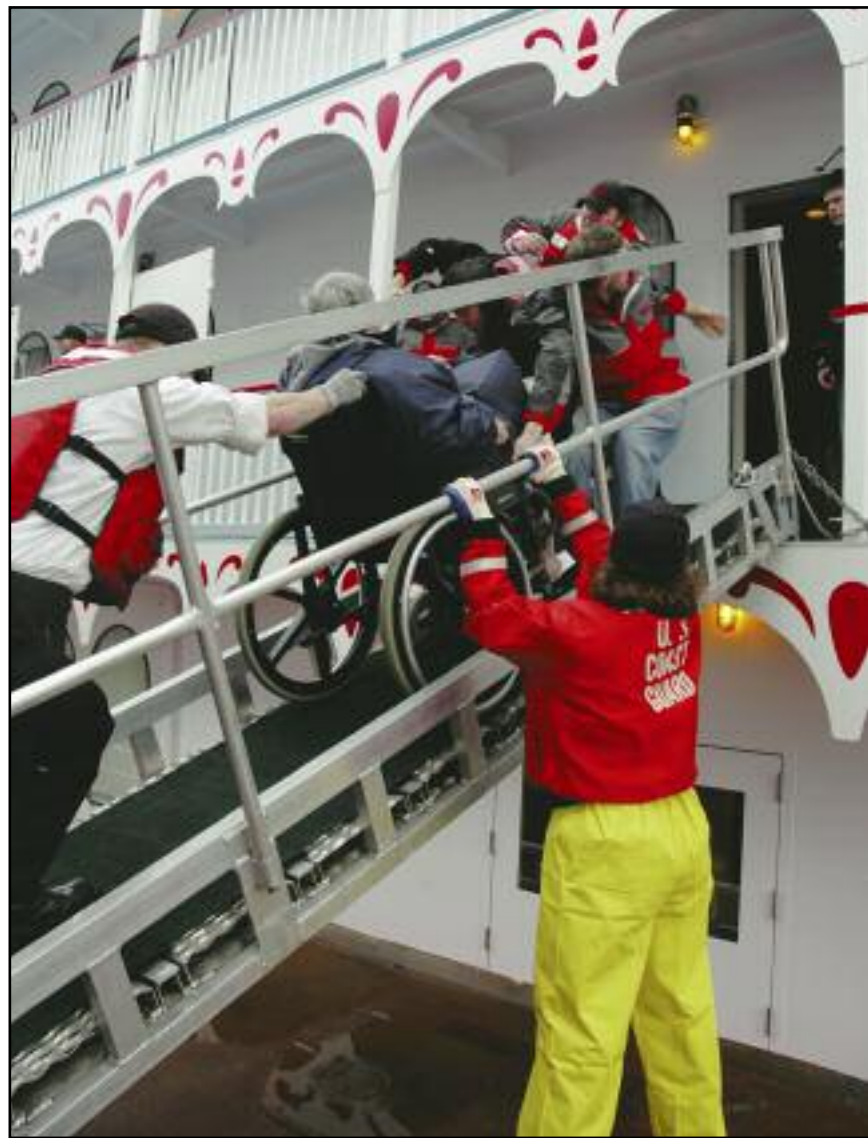
Figure 3: MST1 Lucia Mack assists passengers with special needs during the passenger transfer. A barge was placed between the *Empress of the North* and the *Queen of the West* to safely facilitate this process. USCG photo by PA1 Amy Gaskill, USCG (ret).

With sector responders and Portland Fire on scene, 240 persons were safely transferred from the barge to the 230-foot *Queen of the West* (Figure 3), accounted for, and delivered to a designated triage area, where a medical team was standing by. Remarkably, no injuries to passengers, crew, or rescue personnel
