HM Government of Gibraltar

Report on the investigation of the collision of

OS 35 and ADAM LNG

And the subsequent grounding of

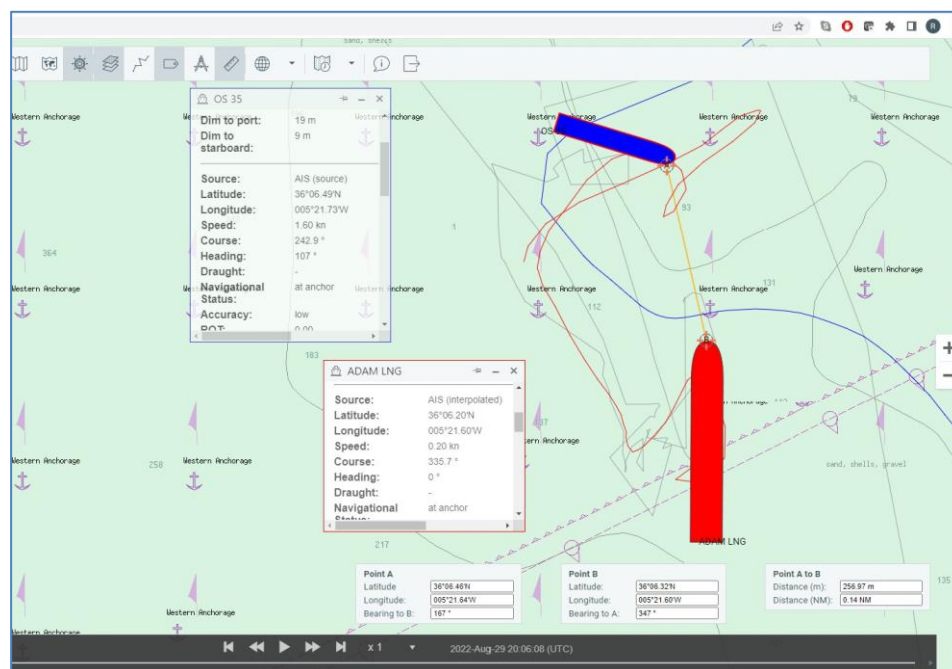
Figure 11 AIS positions of 'OS 35' and 'ADAM LNG' at 22:06:08

At 22:06 'OS 35' informed VTS that they were now underway, and then provided VTS with their destination of the Netherlands when requested. The positions of the two vessels at this time is shown at Figure 11. Shortly afterwards the VTSO asked 'OS35' "...How do you intend to pass with the vessel south of you? How do you intend to pass 'ADAM LNG?' The reply from 'OS 35' was that they would "Pass around the vessel".

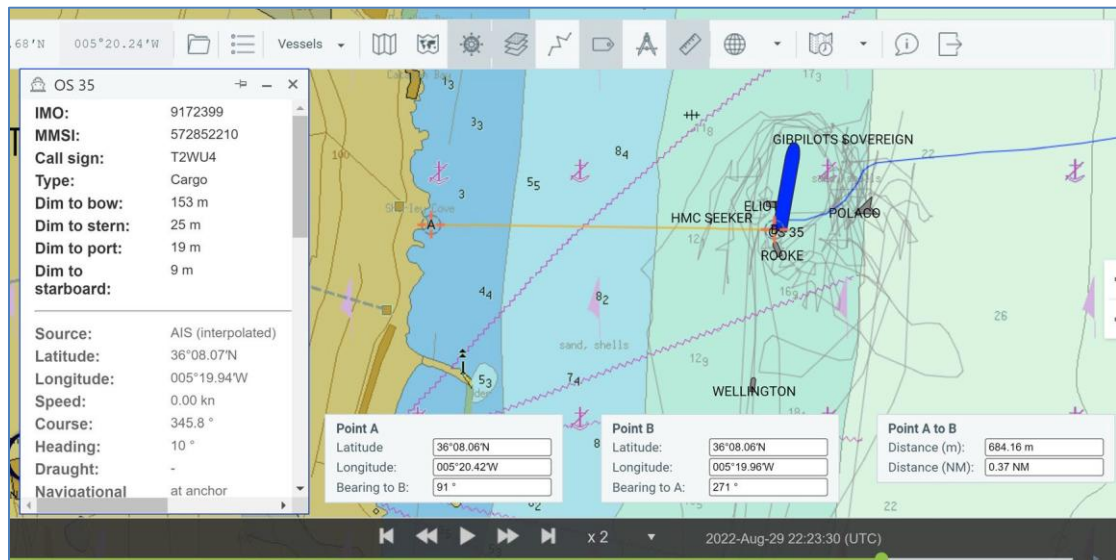
Figure 19 Rapid Replay reconstruction of the position of 'OS 35' at 00:23:30 on 30 August 2022

At around 00:15 the tugs ‘ROOKE’ and ‘ELIOT’ arrived at the position of ‘OS 35’ and offered to evacuate the crew if required. The vessels in attendance at 00:23 are shown at Figure 19.
